Operational experiences of Datawell waverider buoys*

S.G. DIWAN**, A.K. SURYAVANSHI** and B.U. NAYAK**

Abstract: The experiences gained by NIO, Goa since 1980 in the use of Datawell waverider buoys under the long-term wave measurement projects applicable to coastal and ocean engineering problems at nine locations along the west and east coast of India are briefly described in this paper. Information on waverider buoys, mooring, deployment and retrieval techniques, and the type of wave recording system used etc. are presented. Various operational problems associated with measuring and recording equipment, leading some times to loss of valuable wave data etc. have also been discussed. The damages occurred to waverider mooring system due to natural as well as man-made causes including remedial measures adopted have been briefly described.

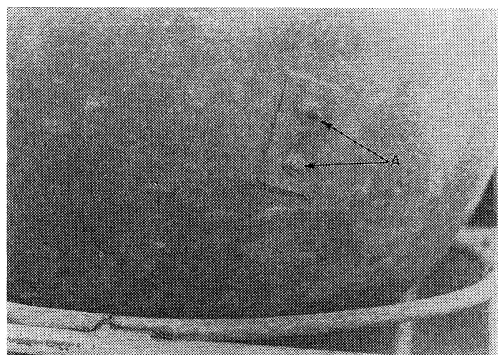
Fig. 4. Failure of U-eye on bottom of waverider buoy (A).

4. Failure of the bottom U-eye of waverider buoy (Fig. 4)	The buoy was drifted to shore & the U-eye was broken by the local fisherman while removing stabilising chain.	Measures are underway to weld a new U-eye to this waverider buoy.	This is a rare problem and has happened during the wave measurements off Daman.

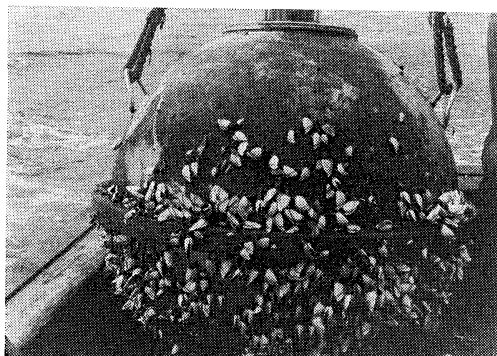
Fig. 5. Growth of barnacles on waverider hull.

6. Partial submergence of the waverider buoy	a) Entanglement of the mooring with plants & bushes during floods in adjoining river. b) Growth of large colonies of barnacles on the waverider surface (Fig. 5).	Periodical checks were carried out by sending divers to check the mooring line during floods in adjoining river. Cunnifer (90/10) buoys are being used in location known for severe biofouling. A few 90 cm dia cunnifer buoys have been procured.	This problem was encountered during the wave measurement off Kakinada. Barnacle growth has resulted in severe pitting on a 316 st. steel buoy deployed at Bombay High.

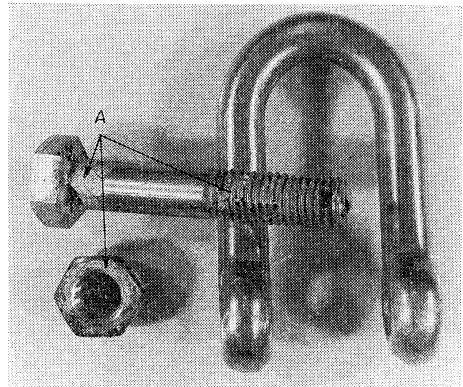
Fig. 6. Corrosion of D-type st. steel 316 shackle (A).

2. Crevice corrosion of D-type 316 st. steel shackle	Formation of oxygen concentration cells in the crevices between U-body, bolt & nut (Fig. 6).	The design of D-shackle is modified, in which the bolt has enough play in the axial direction after tightening the nut. In few instances, zinc sacrificial anodes were clamped to the shackle (Fig. 7).	The modified D-shackles worked satisfactorily.
